Elemental Solutions LLC

General Information

BUILDING ADDRESS: 101 Example Report way
CITY: Ogden
STATE: Ut
ZIP CODE: 84401
INSPECTION DESCRIPTION: Residential
SQUARE FOOTAGE: 2100

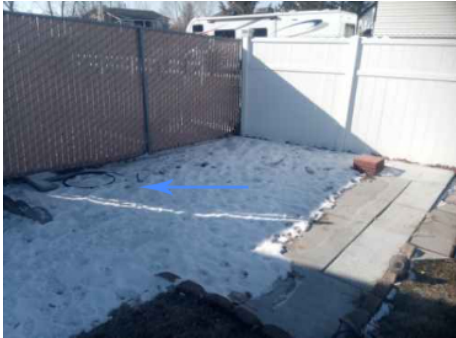
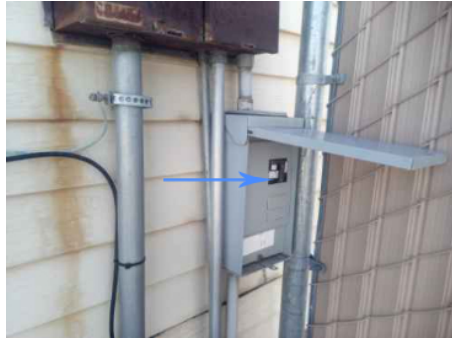
Jacuzzi pad in place, jacuzzi removed by current owner. Note wiring adjacent but cut off. This is disconnected at exterior subpanel. Recommend further evaluation by licensed electrician.

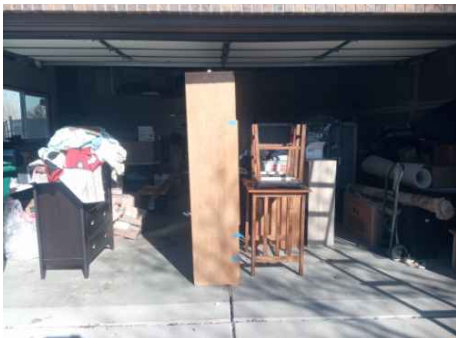
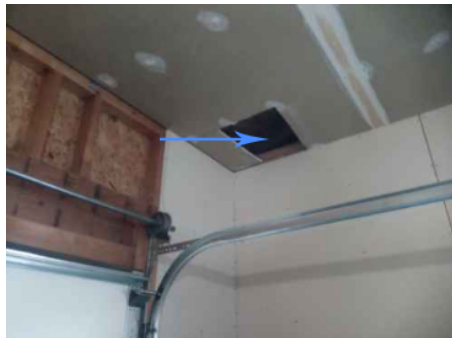
Note: Small piece of sheetrock missing from front west corner. Sheetrock slows the spread of fire, so having garage completely covered is a good idea. Recommend having a handyman complete the installation.

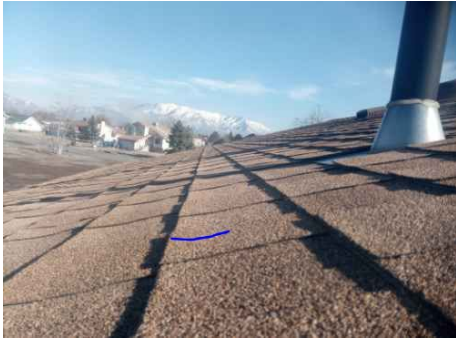
Unable to determine age however in good condition at time of inspection.
Shingles on North slope have minor cupping, showing some age.
Recommend budgeting for eventual replacement.

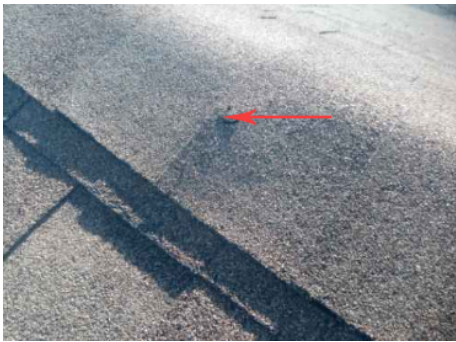
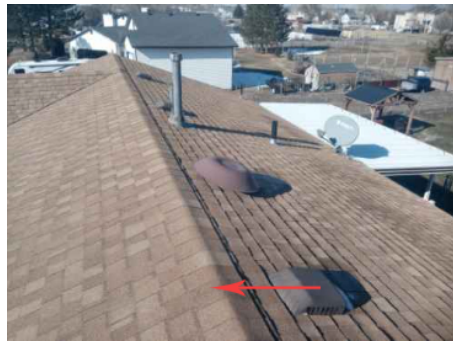
Several nails at ridge and on sides have popped up, recommend sealing by a qualified roofing contractor.

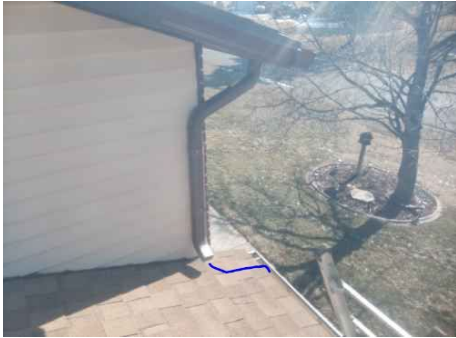
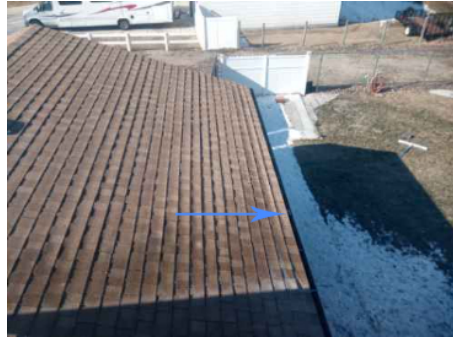
North side of garage roof has some toys and leaves accumulation, recommend regular maintenance by roofing contractor. Upper roof downspout empties onto shingles at front of garage near eave, this causes premature aging, recommend addition of downspout extension into nearby gutter by qualified roofing contractor

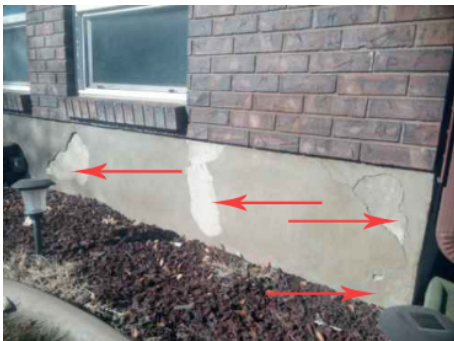
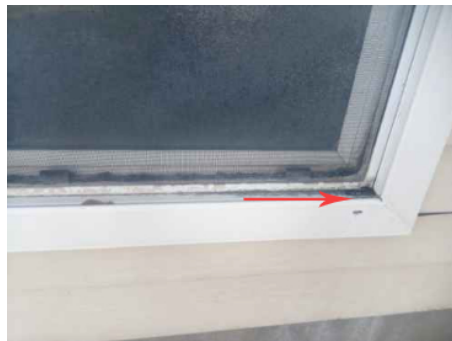
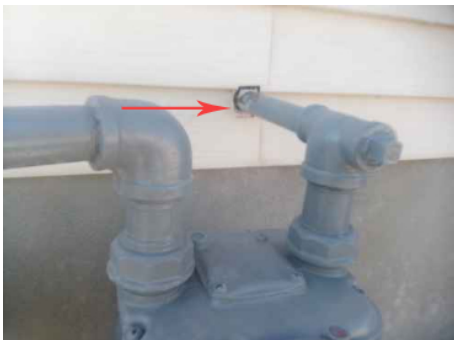
Stucco peeling at SE corner, can allow moisture into foundation, recommend qualified siding specialist.

Holes in West Alum siding could benefit from sealing, recommend handyman or siding contractor

Gas line into foundation unsealed, allows heat loss, possibly moisture and insect intrusion.

Possible mold growth at lower bathroom window bottom, can adversely affect indoor air quality when window open, recommend testing by qualified mold specialist.

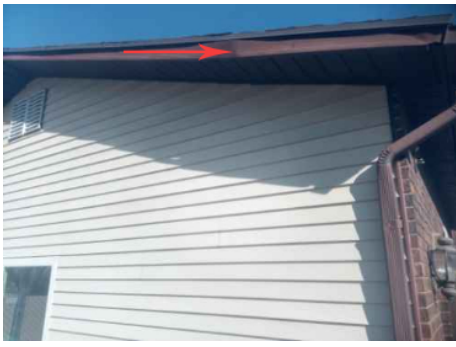
West side of garage trim buckled, can allow moisture intrusion, recommend handyman or qualified roofing contractor.

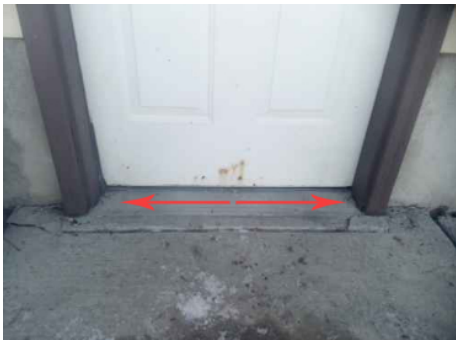
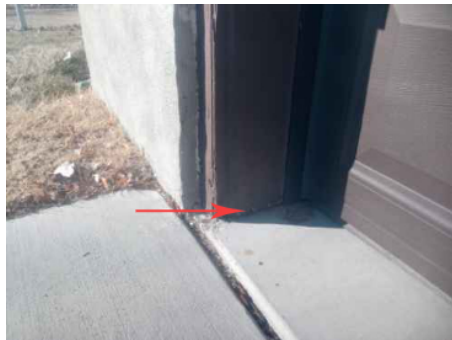
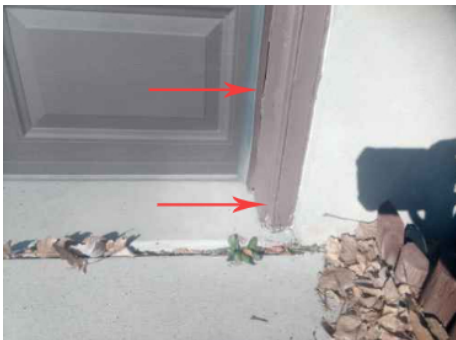
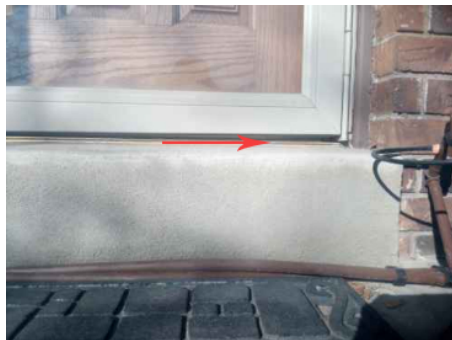
Front door weatherstrip torn, contributes to heat loss, recommend handyman.

Garage front and rear door frames dry rotted, esp at bottom, was dry at time of inspection and appears recently painted. Recommend monitoring situation.

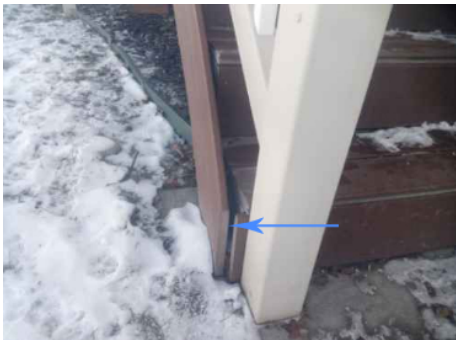
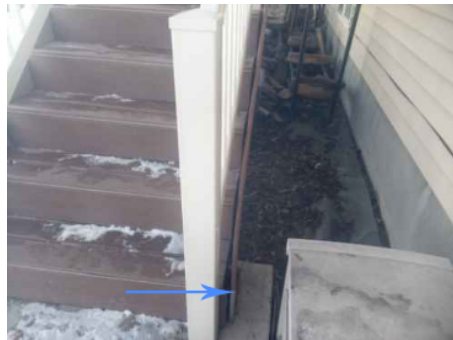
Deck stair sides peeling off, may eventually come off entirely, recommend handyman or qualified decking contractor.

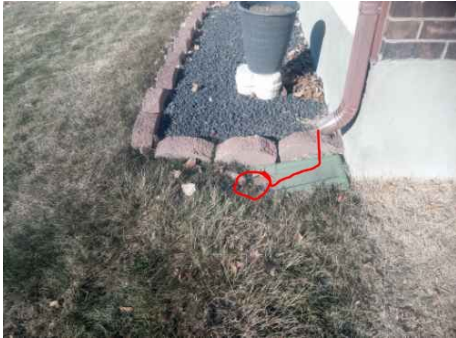
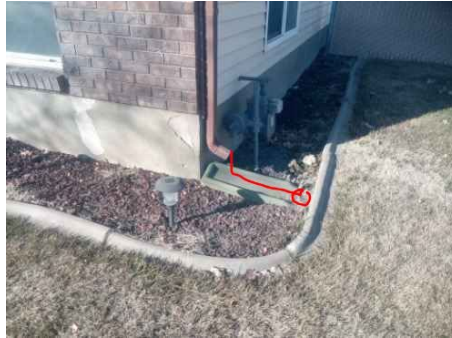
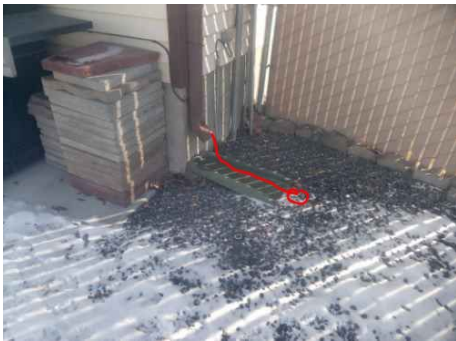
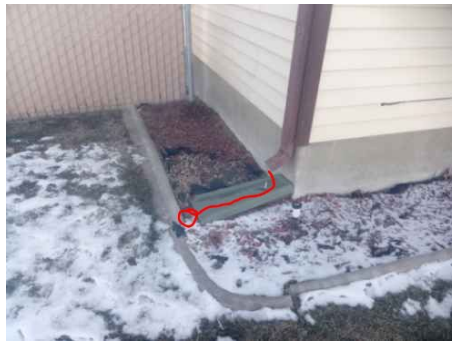
All roof downspouts empty close to house, adds moisture around foundation, recommend handyman or licensed landscaper add extensions

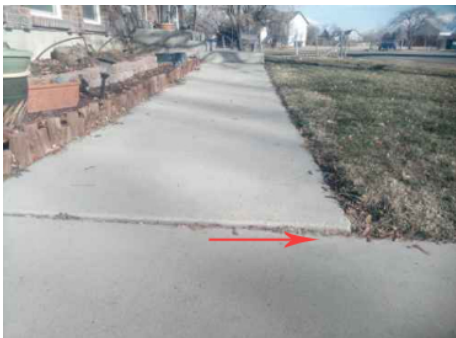
Uneven transition from driveway to sidewalk, trip hazard, recommend qualified Concrete contractor or handyman

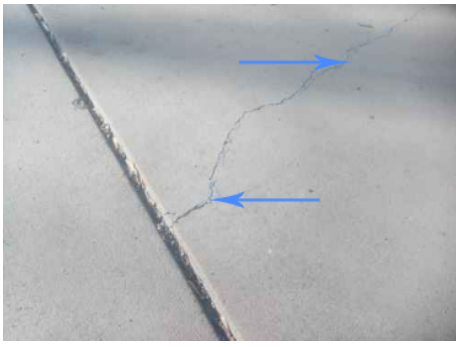
Normal cracking of driveway surface, can continue to deteriorate without sealing, recommend handyman or concrete contractor.

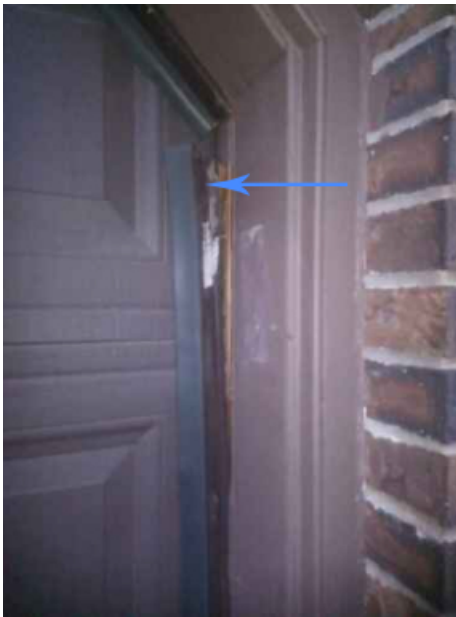
Trim at East side loose, recommend handyman.

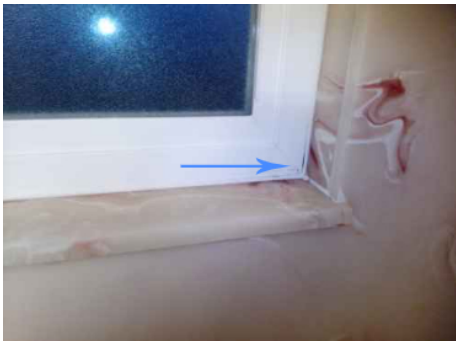
Master bath window would benefit from fresh caulk to reseal and remove minor staining, recommend handyman or qualified contractor

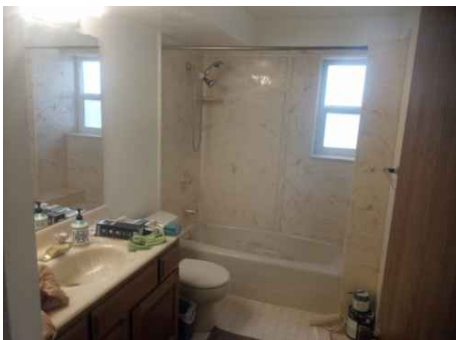
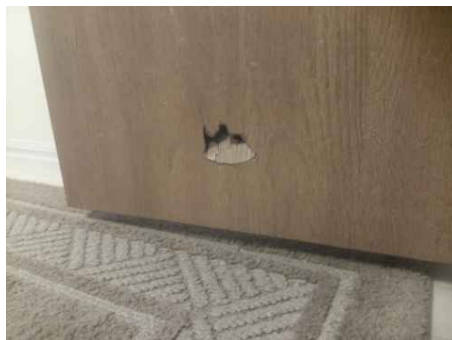
Current owner says in process of some remodeling. At time of inspection door has hole at bottom, recommend asking current owner if this will be repaired

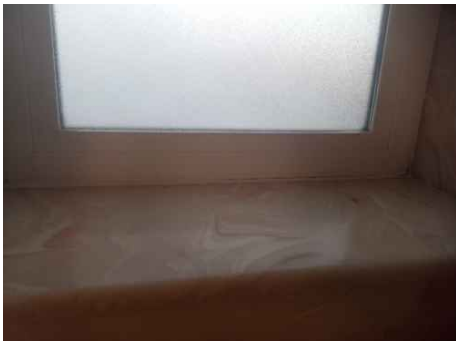
Some gaps in caulking on bottom of window, allows heat loss and moisture intrusion into wall cavity, recommend handyman or qualified contractor.

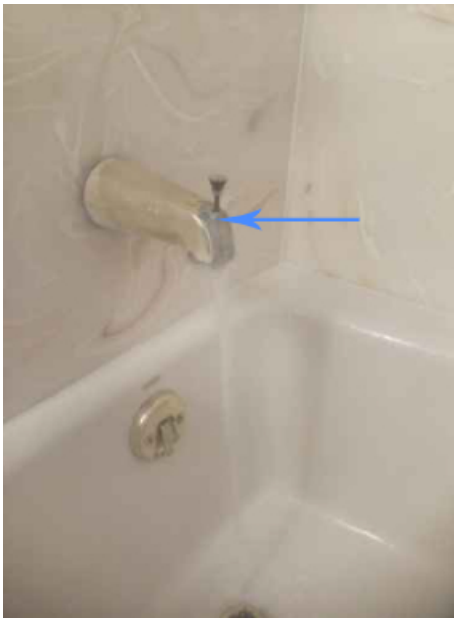
Valve for shower leaks greatly reducing pressure to shower head, recommend evaluation by licensed plumber.

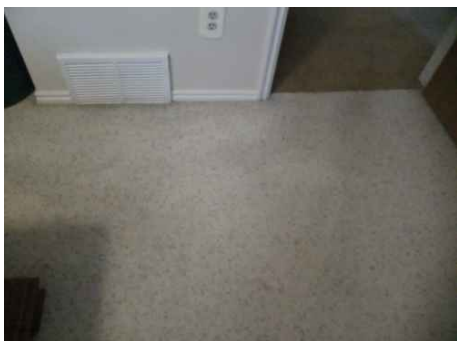
Very minor staining from normal wear & tear, overall very good cond for used carpeting, recommend professional cleaning service

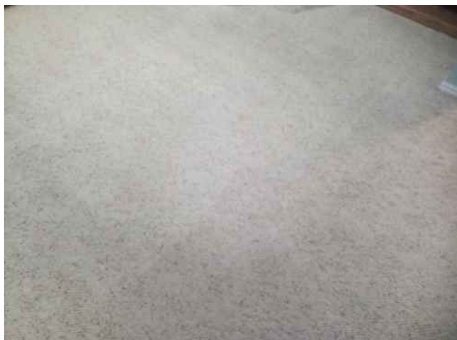
Some minor staining on this carpet, recommend professional cleaning service.

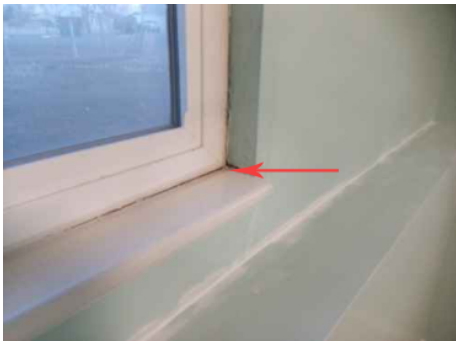
1 of 3 windows has caulking in poor cond at time of inspection, current owner says will be recaulked by final walkthrough. Also that blinds will be reinstalled.

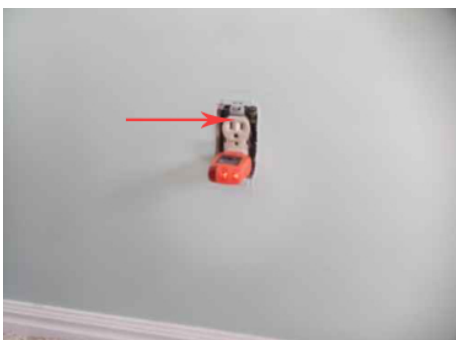
All 5 outlets test good however none have protective covers. Same for light switch. Current owner says will be reinstalled before final walkthrough. Recommend checking that this is accomplished as open wiring is a safety hazard.

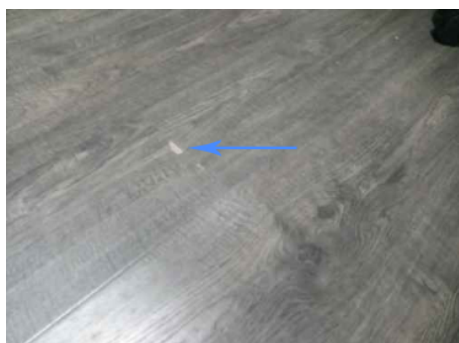
Laminate. One spot in center of floor chipped.

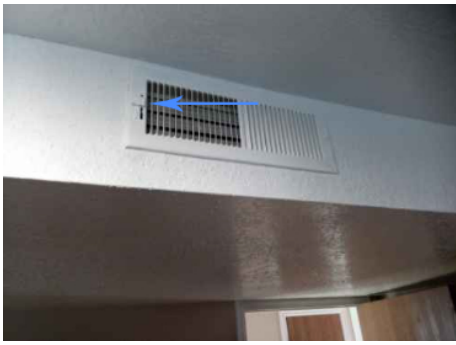
Heat vent painted, no longer adjustable, recommend handyman.

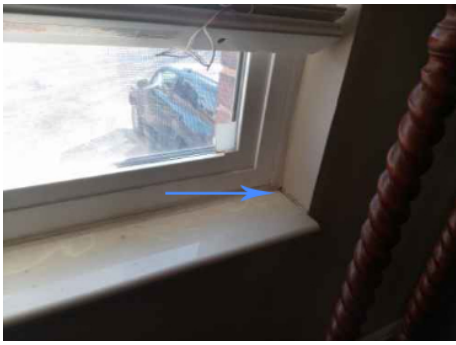
Caulking cracked, recommend handyman or qualified contractor.

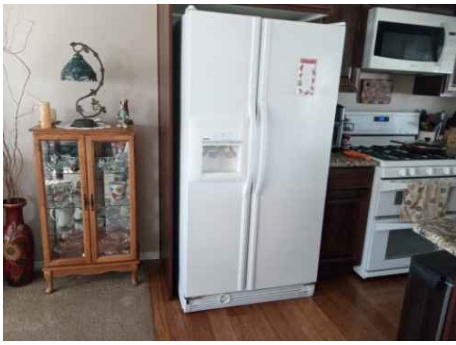
Kenmore Cold spot MFR date 07/1999 runs fine at end of life expectancy, recommend budget for eventual replacement

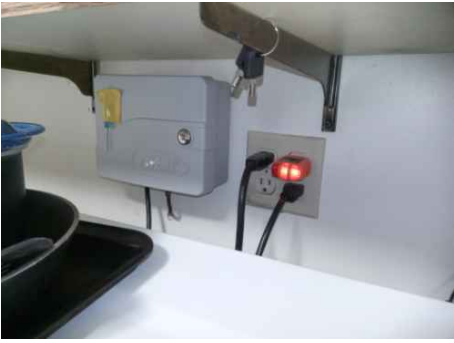
2 outlets test good should be GFCI protected for wet environment, recommend if you ever do elec work on house upgrade these while at it

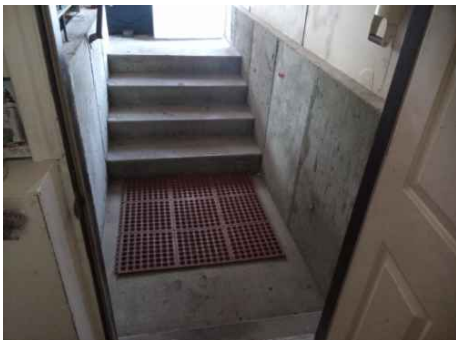
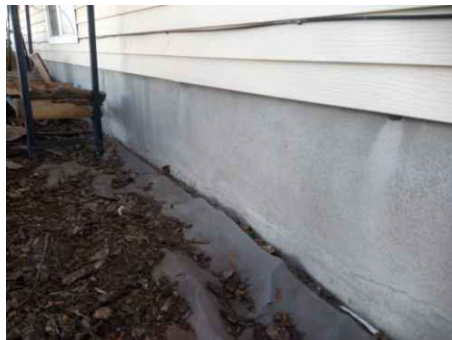
Good cond only a few typical hairline cracks

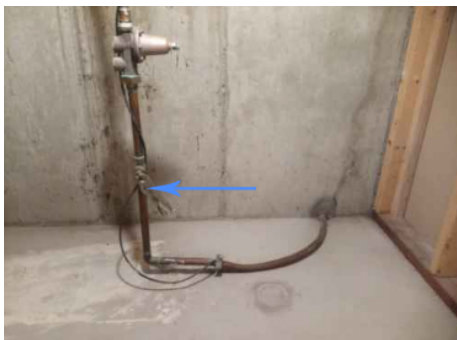
Note: valve handle missing, vice grip pliers attached, recommend if you ever have plumbing work done get proper handle installed.

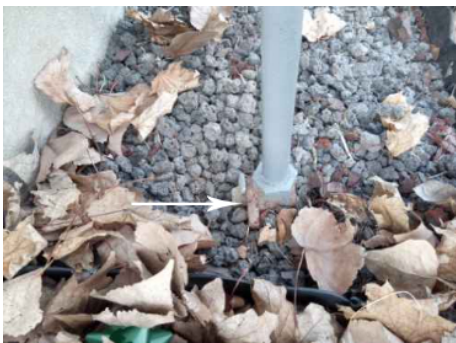
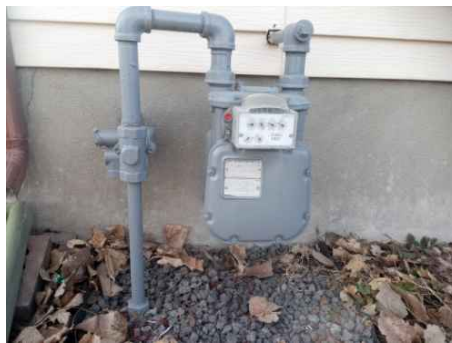
Gas meter located SE corner of house. 3/4" Supply pipe rated at 250,000 BTUs. The shut off valve (noted in close up with white arrow is almost buried) recommend clearing landscape material back for access.

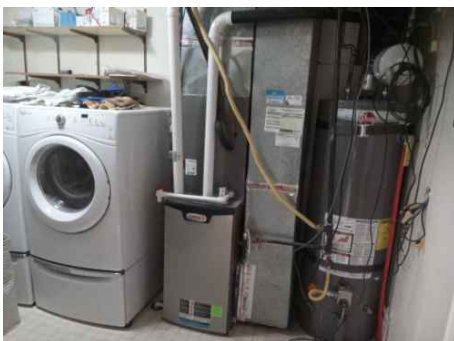
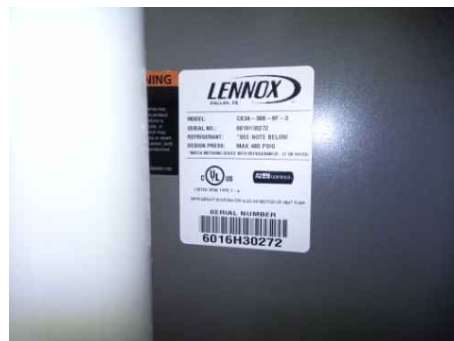
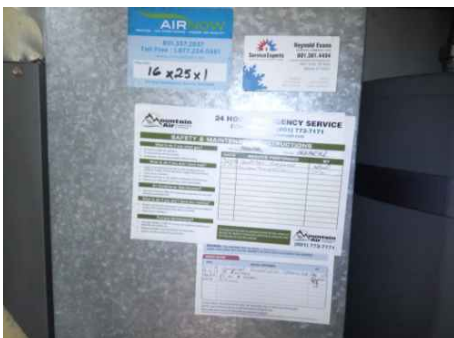
Lennox 90+% efficient MFR date 2016

Most recent service showing is 10/2019, recommend having unit serviced by qualified HVAC technician

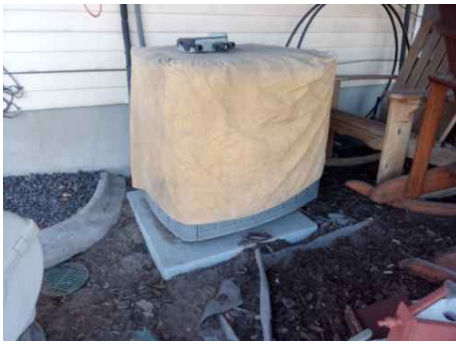
Compressor unit winterized for season, recommend qualified HVAC tech check unit before operating in Spring

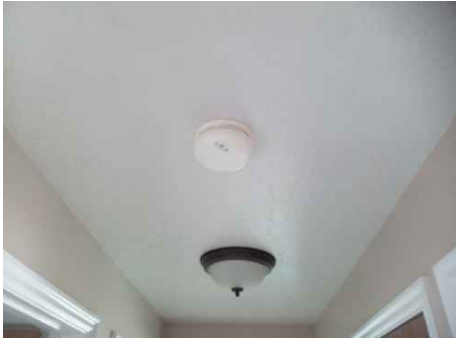
Only one CO2 / smoke detector found, located in downstairs hallway. Age unknown. Recommend installing minimum one near kitchen / living area and one at entrance to all bedroom areas.
