Elemental Solutions LLC

General Information

BUILDING ADDRESS: 101 Example Report way
CITY: Ogden
STATE: Ut
ZIP CODE: 84401
INSPECTION DESCRIPTION: Residential
SQUARE FOOTAGE: 2100

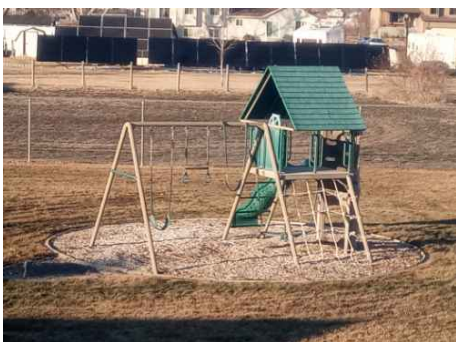
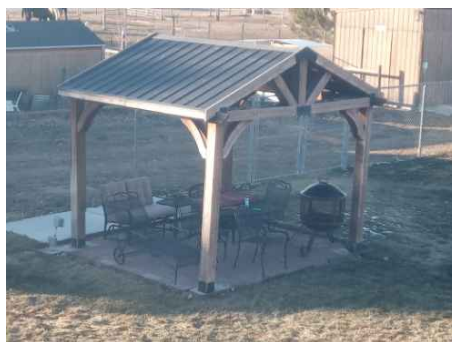
Gazebo and child's swing set present, not inspected per SOP

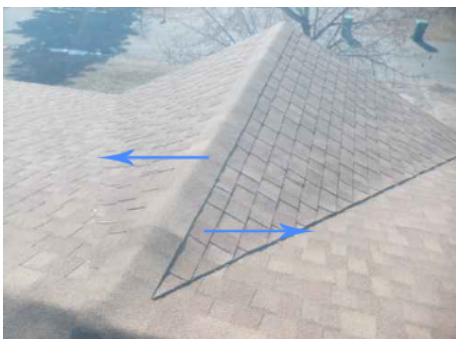
Dormer could benefit from metal flashing at valley, however not required with this overlap of material

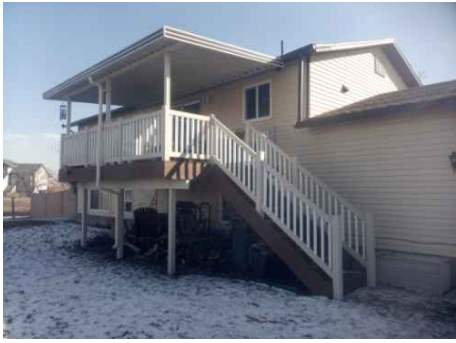
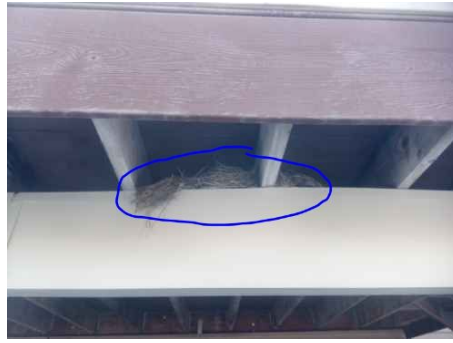
Overall good cond.

Note: bird's nest on deck support beam.

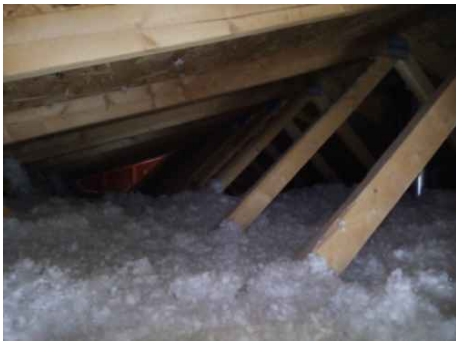
W Engineered Truss

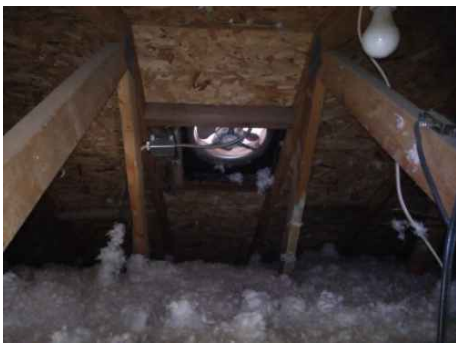
Blower fan to wall switch

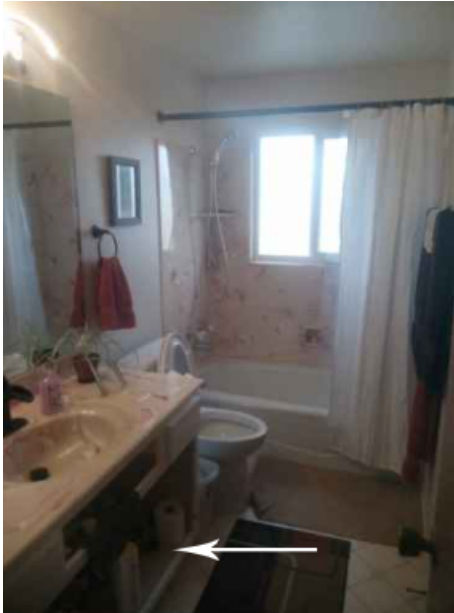
Current homeowner says working on cabinet doors, will be finished prior to final walkthrough.

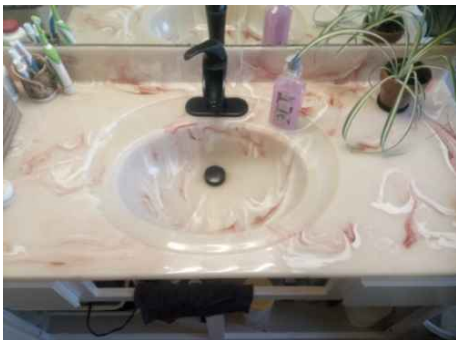
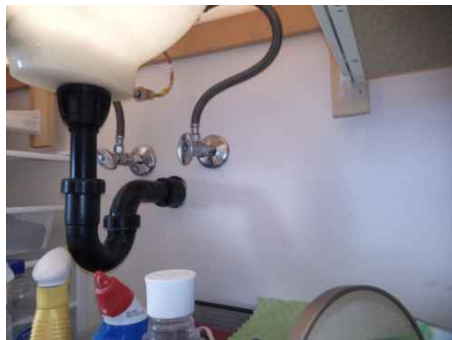
Note: sink & counter one piece

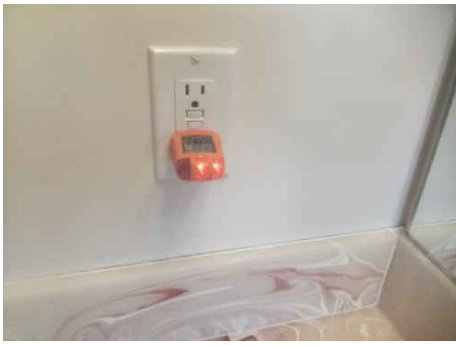
Only one for this room. Tests good.

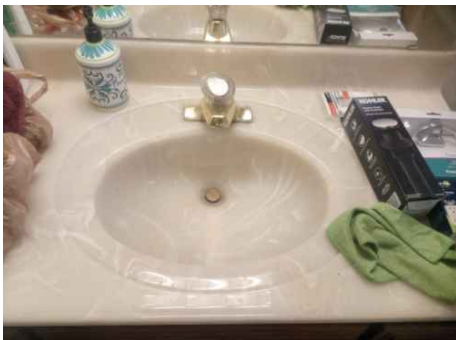
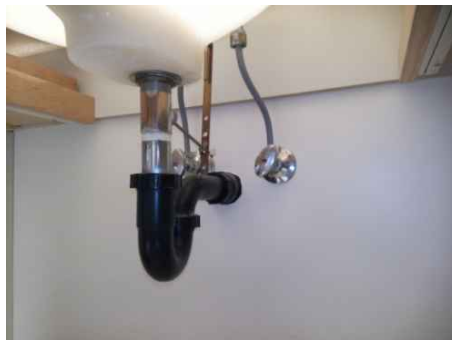
Same style one piece sink & counter as master bath.

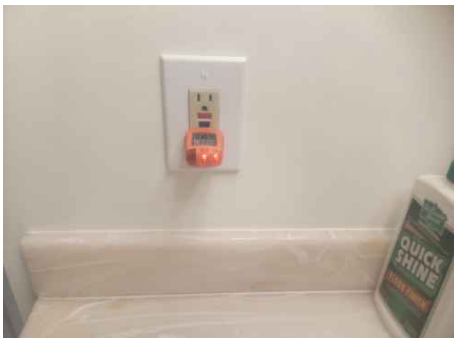
This room also has only one outlet. Tests good.

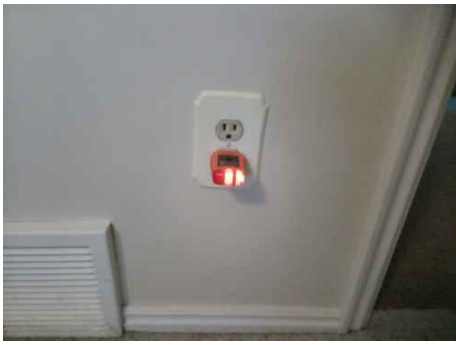
3 outlets tested good, could not test one or more others due to current resident's belongings.

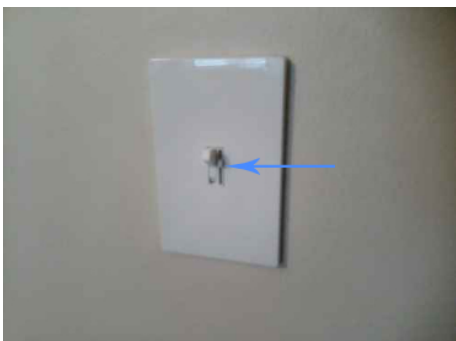
Ran and works however does not operate the best with variable switch.

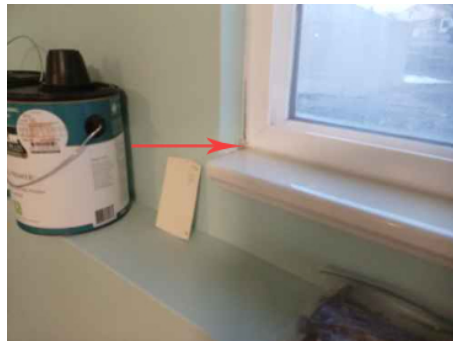
1 of 3 windows has caulking in poor cond at time of inspection, current owner says will be recaulked by final walkthrough. Also that blinds will be reinstalled.

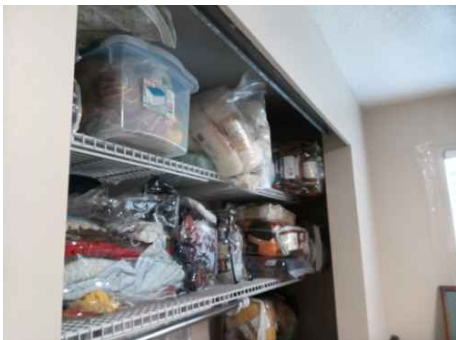
Sliding doors removed. Current owner says they are in garage if you want to reinstall them. I looked at the track and doors, they look fine.

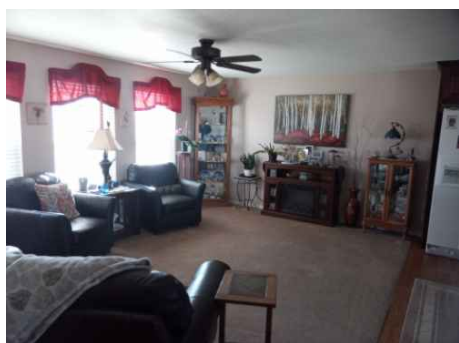
Open to kitchen and dining areas.

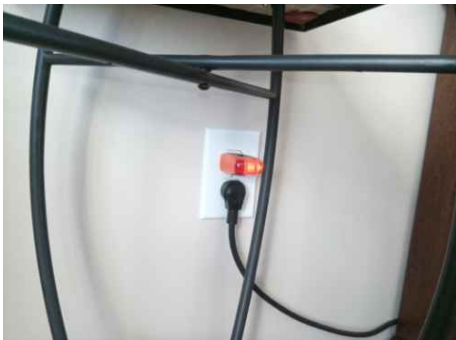
4 outlets test good

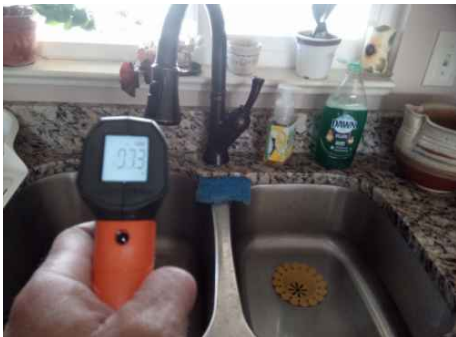
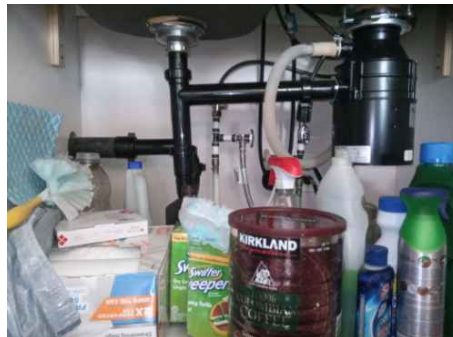
SINK / GARBAGE DISPOSAL Satisfactory

60/40 undermount w/ disposal on right

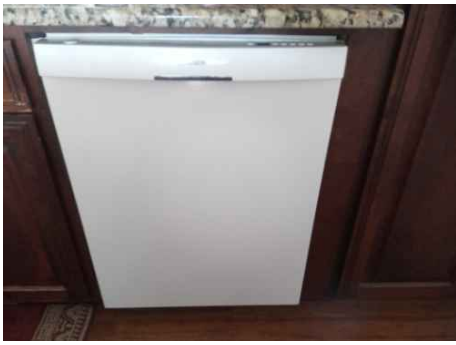
DISHWASHER Satisfactory

Bosch MFR 2004 ran through cycle

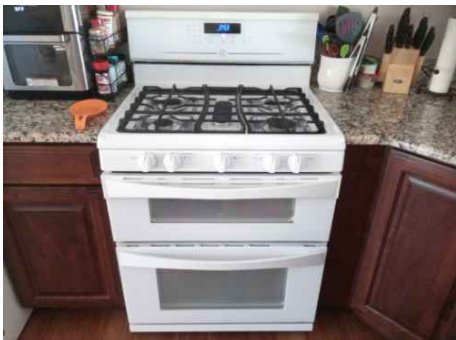
STOVE / OVEN Satisfactory

Kenmore Elite double oven gas MFR date unknown all burners and ovens ignite properly

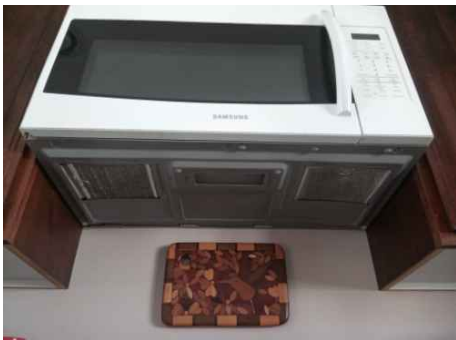
EXHAUST HOOD Satisfactory

Over counter microwave with vent to outside

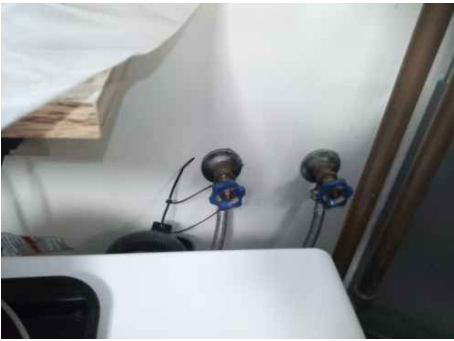
Gate valve type located behind dryer

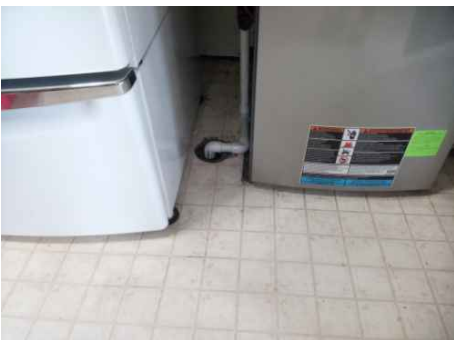
DRAINAGE Satisfactory

Floor drain shared with furnace and HW heater

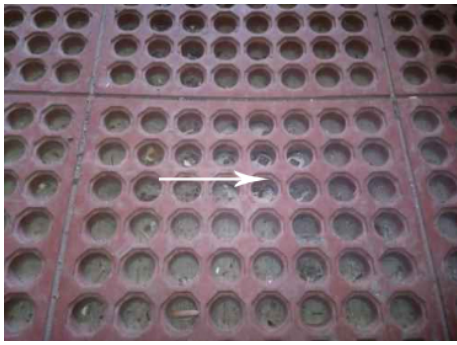
Floor drain at bottom of stairs to garage under may

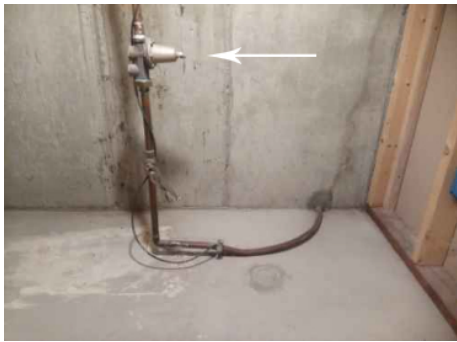
3/4" copper main w/ press regulator located under stairs in closet.

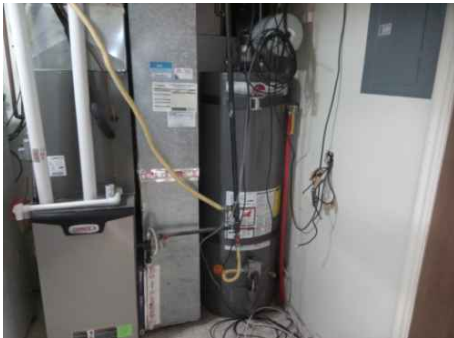
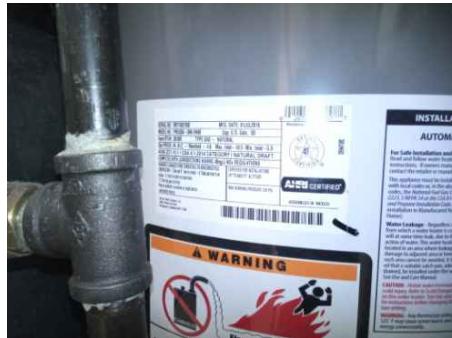
Rheem 50 gal gas fired tank heater, MFR date 06/2016

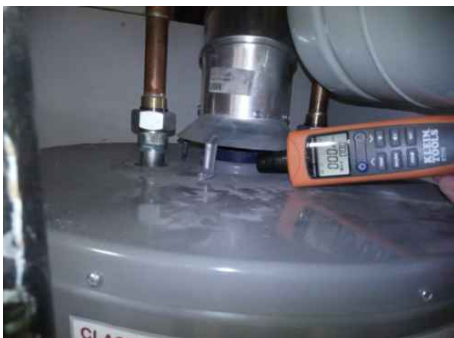
VENT SYSTEM Satisfactory

Vent properly installed w/ no CO detected

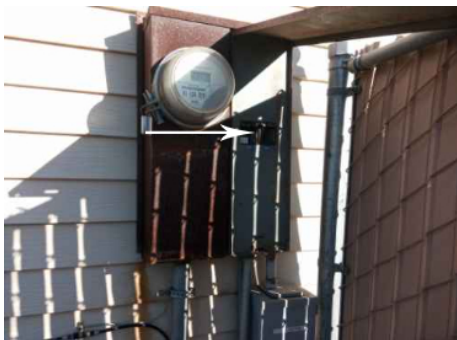
Located outside NW corner in right panel

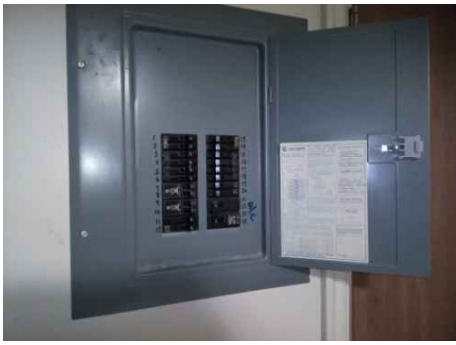
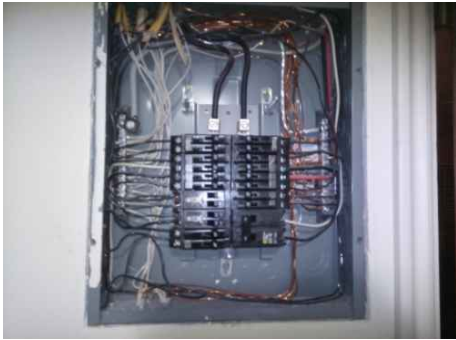
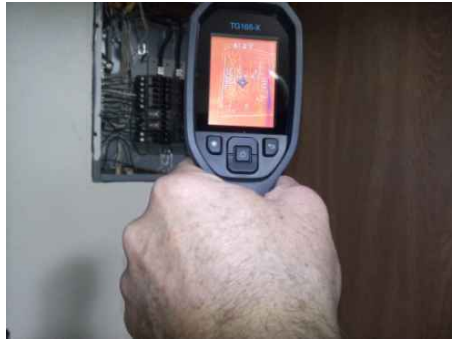
Located in laundry room

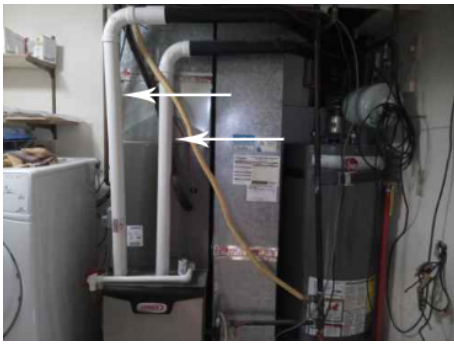
Vents at roof

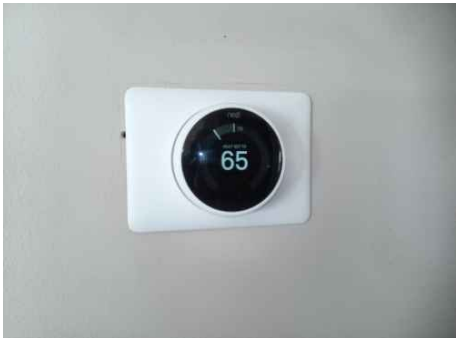
Nest smart thermostat installed

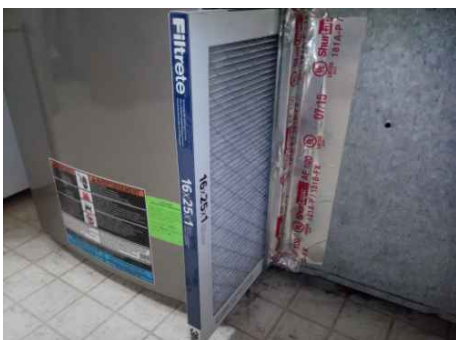
AIR FILTER(S) Satisfactory

HVAC filter size 16 X 25 located at base of furnace facing front

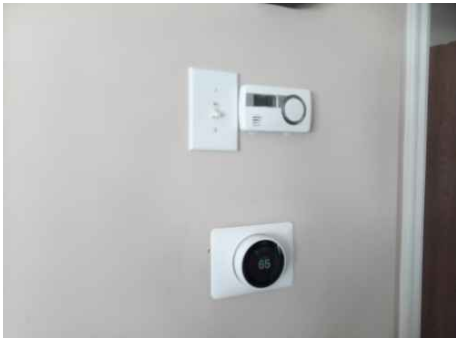
CO detector located top of stairs. Age unknown
